ASSESSING PIPELINE INTEGRITY USING SINGLE RUN IN-LINE INSPECTION DATA

Data from a Magnetic Flux Leakage In-Line Inspection of a 24" x 47 km carbon steel pipeline carrying crude oil in the Niger Delta, Nigeria were analyzed to determine current integrity of the pipeline relative to its operational regime. The pipeline has been in active operation for 14 years before the inspection. Although over 500,000 metal loss features were recorded, less than 0.01% was assessed to be significant. Integrity of the pipeline is therefore rated high. 'Water carry over' into the pipeline and 'water separation' in the pipeline during transmission are adduced to be the major causes of the metal loss observed. Efficiency of processing the product (how dehydrated or de-aerated the oil and gas is respectively) and how constant the transmission velocity and pressure are maintained throughout the pipeline are found to be, more than other factors, the determinants of the rate of deterioration of a pipeline actively carrying fluids.

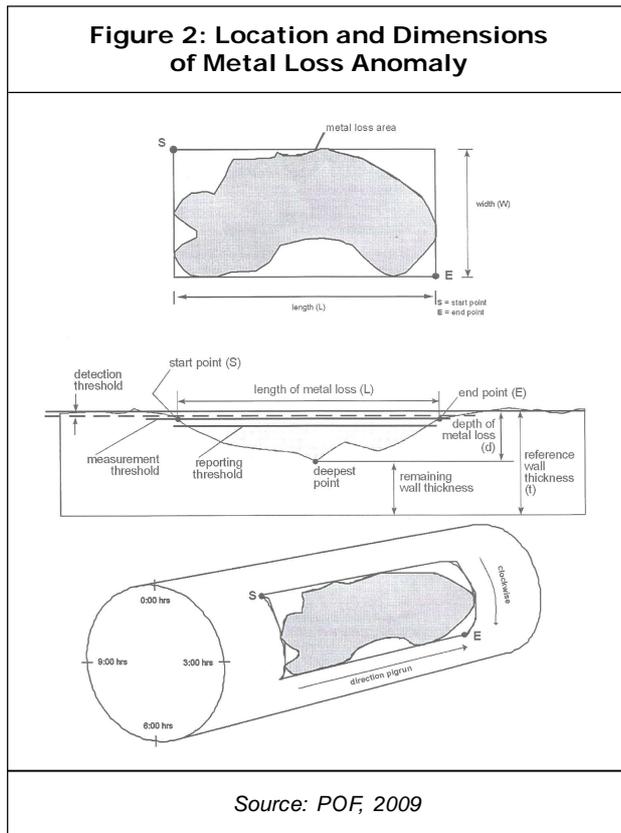
- Length, L, (how long is a flaw from beginning to end, extent in the direction of the pipe)
- Depth, d, (how deep is the flaw, deepest point)
- Width, W, (how wide is the flaw, circumferential extent)
- Circumferential position (orientation, O’Clock position of a flaw)
- Longitudinal position (Figure 2).

Figure 2: Location and Dimensions of Metal Loss Anomaly

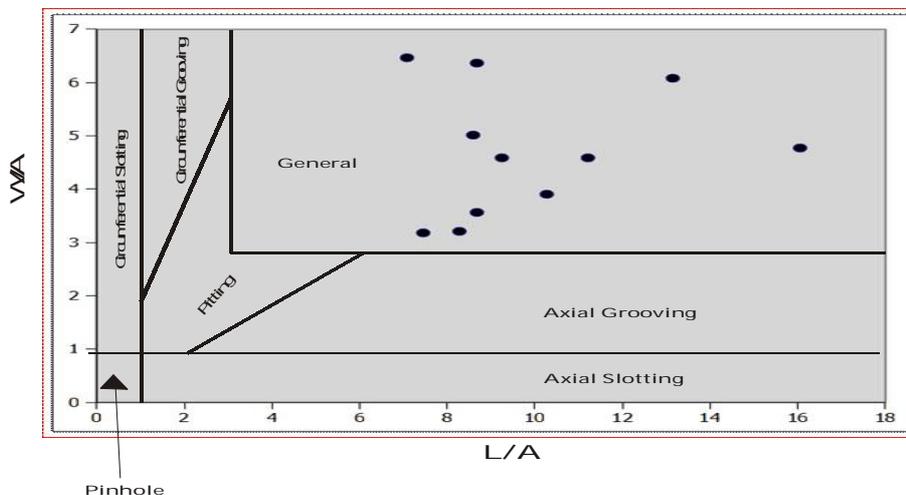
Figure 3: W/A versus L/A Plot. Graphical Presentation of Metal Loss Anomalies Per Dimension Class (After Pof2009) Showing Metal Loss From This Study as General Corrosion

are so closely spaced (11 of them occurring within a 2.4 km space) that they require special attention. All 12 features also plot on the general corrosion field in the W/A; L/A plot (Figure 3).

Anomaly Dimension class	Definition
General	$\{(W>3A) \text{ and } L> 3A \}$
Pitting	$\{(1A<W<6A) \text{ and } (1A<L<6A) \text{ and } (0.5<L/W<2) \text{ and not}\{ (W>3A) \text{ and } (L<3A) \}$
Axial Grooving	$\{(1A<W<3A) \text{ and } (L/W>2)\}$
Circumferential Grooving	$\{(L/W<0.5) \text{ and } (1A>L<3A)\}$
PinHole	$\{(0<W<1A) \text{ and } (0<L<1A)\}$
Axial Slotting	$\{(0<W<1A) \text{ and } (L>1A)\}$
Circumferential Slotting	$\{(W<1A) \text{ and } (0<L<1A)\}$
